# Manhole Inspection Summary

Manhole # S33W\_\_010MH

Insp Date: **2/11/08 3:27 PM**

**Location** Address: **1753 clarkson st**

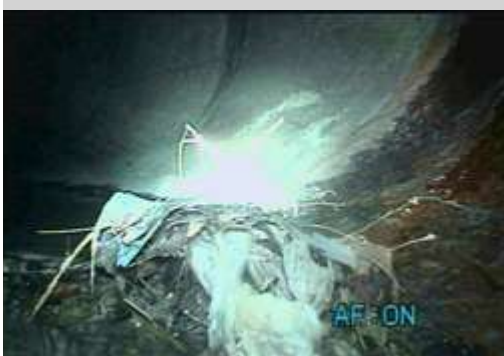
Defect 1

channel debris

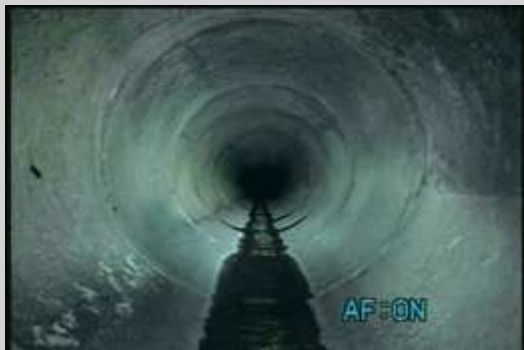
12 O'Clock Outflow

24 in. Circular Gravity Sewer  
Pipe Out @ 12 O'Clock

Invert Depth: **14.10** (ft.) Flow Characteristics: **Slow**

Deposits: ☒ None ☐ Mud ☐ Sludge ☐ Debris ☐ Grease

Infiltration: **None**

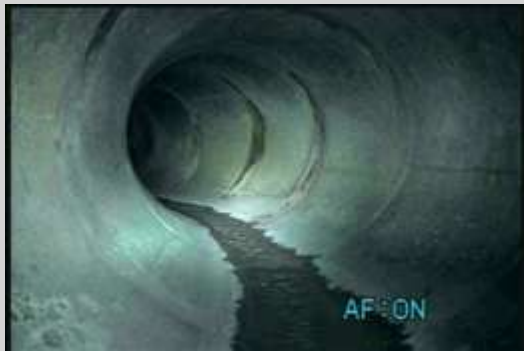
6 O'Clock Inflow

24 in. Circular Gravity Sewer  
Drop In @ 6 O'Clock

Invert Depth: **14.00** (ft.) Flow Characteristics: **Slow**

Deposits: ☒ None ☐ Mud ☐ Sludge ☐ Debris ☐ Grease

Infiltration: **None**
